The Commonwealth of Massachusetts  
Executive Office of Health and Human Services  
Department of Public Health  
250 Washington Street, Boston, MA 02108-4619

September 11, 2001

In response to a request from employees of the Lawrence Juvenile Court, the Bureau of Environmental Health Assessment (BEHA) conducted an evaluation of the indoor air quality at Lawrence Juvenile Court, 10 Railroad Street, Lawrence, Massachusetts on June 29, 2001. This evaluation followed a discussion with Christopher McQuade of the Administration Office of the Trial Court. Michael Feeney, Chief of Emergency Response/Indoor Air Quality (ER/IAQ), BEHA, conducted this inspection. Concerns about mold exposure related to flooding in the basement resulting from a rainstorm on June 17, 2001 prompted this request. Courthouse staff reported that rainwater accumulated to a depth of four to six inches throughout the basement floor of the building. Materials forming interior walls of the front lobby, cellblock, cellblock control and the District Attorney's Office became saturated with water. Unremediated sections of the interior wall cavity showed signs of mold growth. These sections are made of gypsum wallboard (se

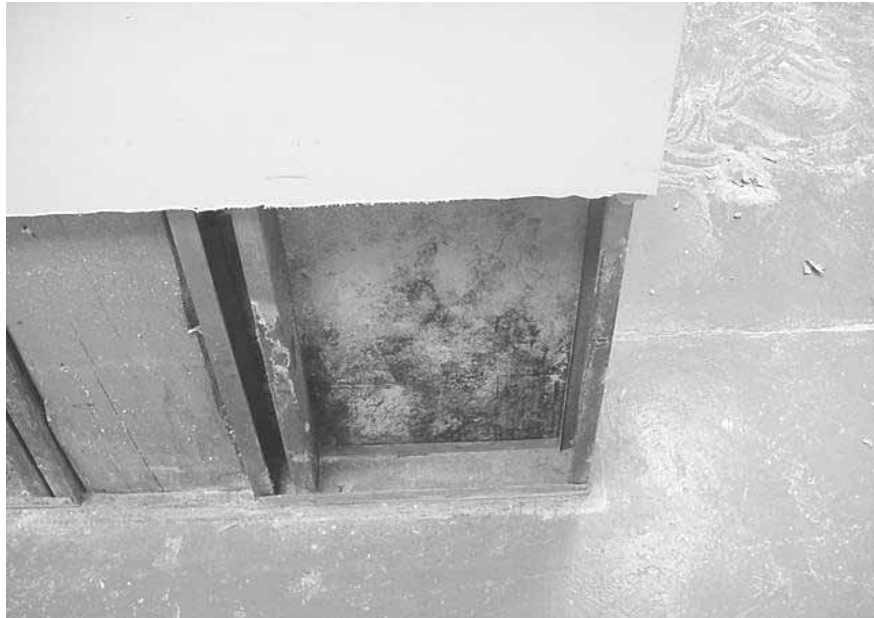
**Picture 1**

**Removed Gypsum Wallboard in Cellblock Hallway, Note Mold Growth on Interior Side of Gypsum Wallboard**

floor of the elevator car. Further, restrooms on the first floor have this plastic covering on walls, except it is adhered to gypsum wallboard. Both water saturated gypsum wallboard and plywood can support mold growth if it remains moistened for extended periods of time. After consulting with Mr. Pat Quinn, (facility manager for landlord of 10 Railroad Street), it was agreed that wallboard in the basement should be removed at a height of two feet above the floor and cell wall plywood be removed at a height of approximately one-foot above the floor.

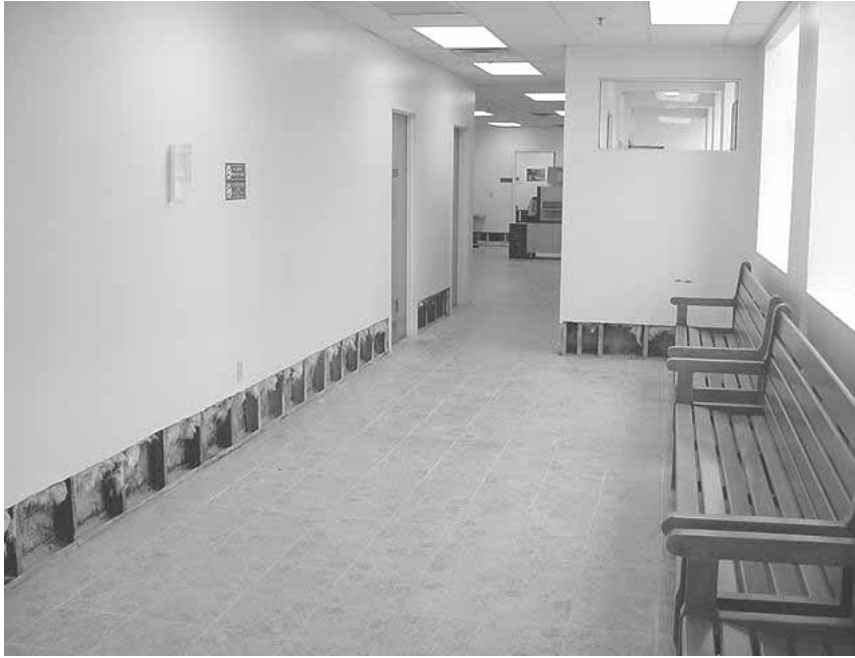
**Picture 2**

Contractors appeared to have made substantial efforts to restore the basement to a workable environment. In a number of areas in the basement, the front lobby and sections in the cellblock hallway of gypsum wallboard as well as insulation were removed (see Picture 2). Floor fans and dehumidifiers were in operation at the time of this assessment. In order to ascertain whether sufficient amounts of wall board were removed to prevent mold growth, moisture content of these materials was measured using a Delmhorst, BD-2000 Model, Moisture Detector. Moisture contents of gypsum wallboard above removed sections in the cellblock hallway had normal moisture concentrations and appeared to be free of visible mold growth. A number of walls in the lobby and the district attorney's office had elevated moisture levels at a height of two feet above the floor.

**Removed One-foot Sections of Gypsum Wallboard and Insulation in the Lobby**

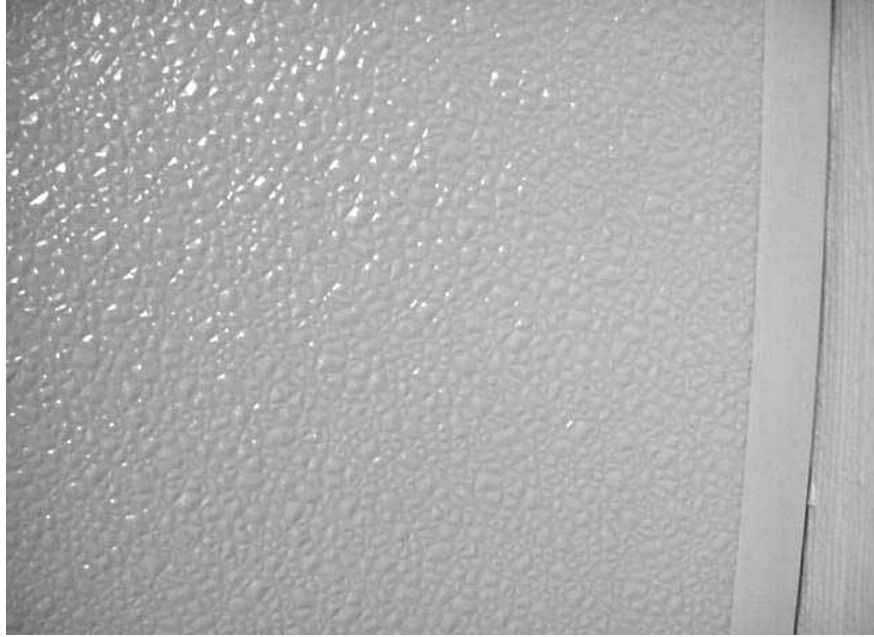
**Picture 3**

Moisture measurements were also taken in cell walls. Cell walls consist of plywood that is covered with a vandalism-resistant, heavy plastic covering (see Picture 3). This plastic covering serves as a water-impermeable plastic barrier that serves to prevent plywood from drying. Plywood at a height of one foot above the floor within wall cavities had excessive measurements of moisture. Similar excessive moisture measurements were also found in the

**Heavy Plastic Material over Plywood that Forms Cell Walls.**

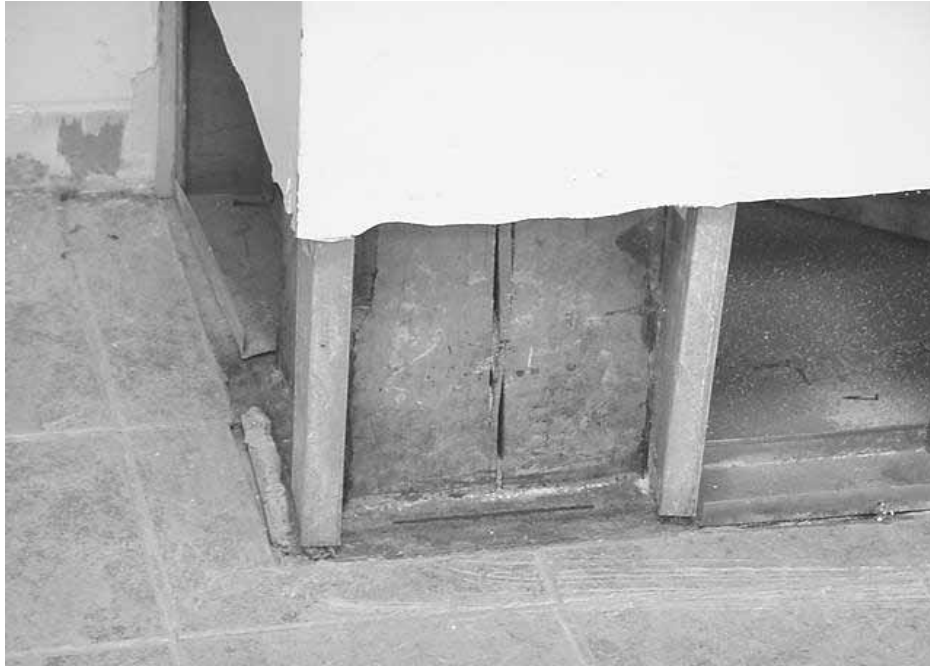
**Picture 4**

**Structural Wood Pillar inside Gypsum Wallboard Cavity in Lobby**

1. Seal elevator, stairwell and hallway doors with polyethylene plastic and duct tape.
2. Continue to use dehumidifiers, particularly around structural wooden beams (see Picture 4).
